# EMS Risk & Recovery Mapping (RRM) service for IRMA hurricane

Experience, lessons learnt, recommendations  
by French institutions

# Request to RRM : reconstruction monitoring during 2 years

## **Example of RRM product (EMSN049)**

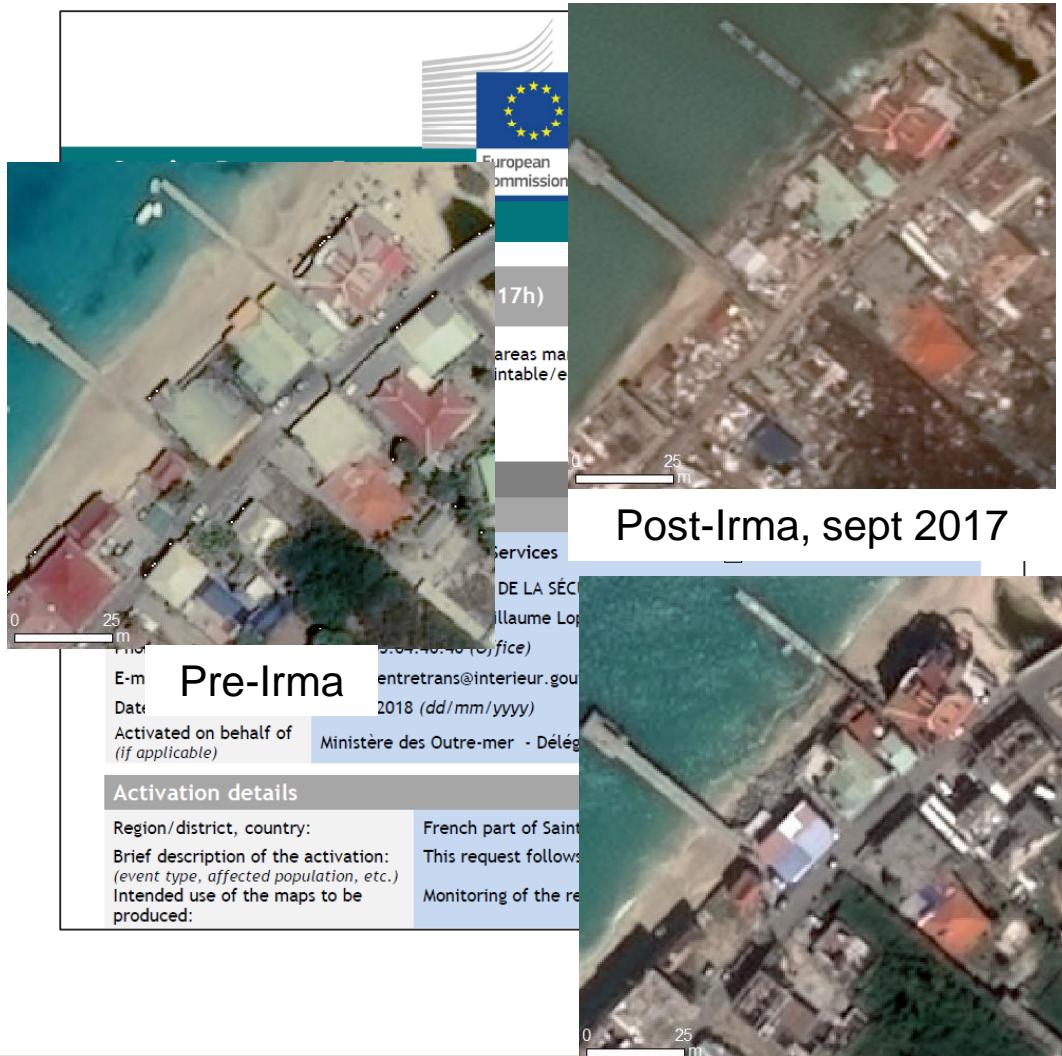
## ❖ Initial status of Buildings Damages (september 2017)

- 4 levels of damages :

Buildings Damage Grading
	01-Negligible to slight damage
	02-Moderate damaged
	03-Severe damaged
	04-Destroyed
	99-Not Applicable (clouds)

## ❖ Buildings reconstruction monitoring (monthly, then trimestrial until sept 2019)

- 5 types of evolution:

Reconstruction Monitoring
	Unchanged structure, 09/2017 - 06/2018
	Removed structure, 09/2017 - 05/2018
	Removed structure, 05/2018 - 06/2018
	Rebuilt structure, 09/2017 - 05/2018
	Rebuilt structure, 05/2018 - 06/2018
	New structure, 09/2017 - 05/2018
	New structure, 05/2018 - 06/2018
	Ongoing rebuilt, 05/2018 - 06/2018
	Not Applicable (clouds), 05/2018 - 06/2018

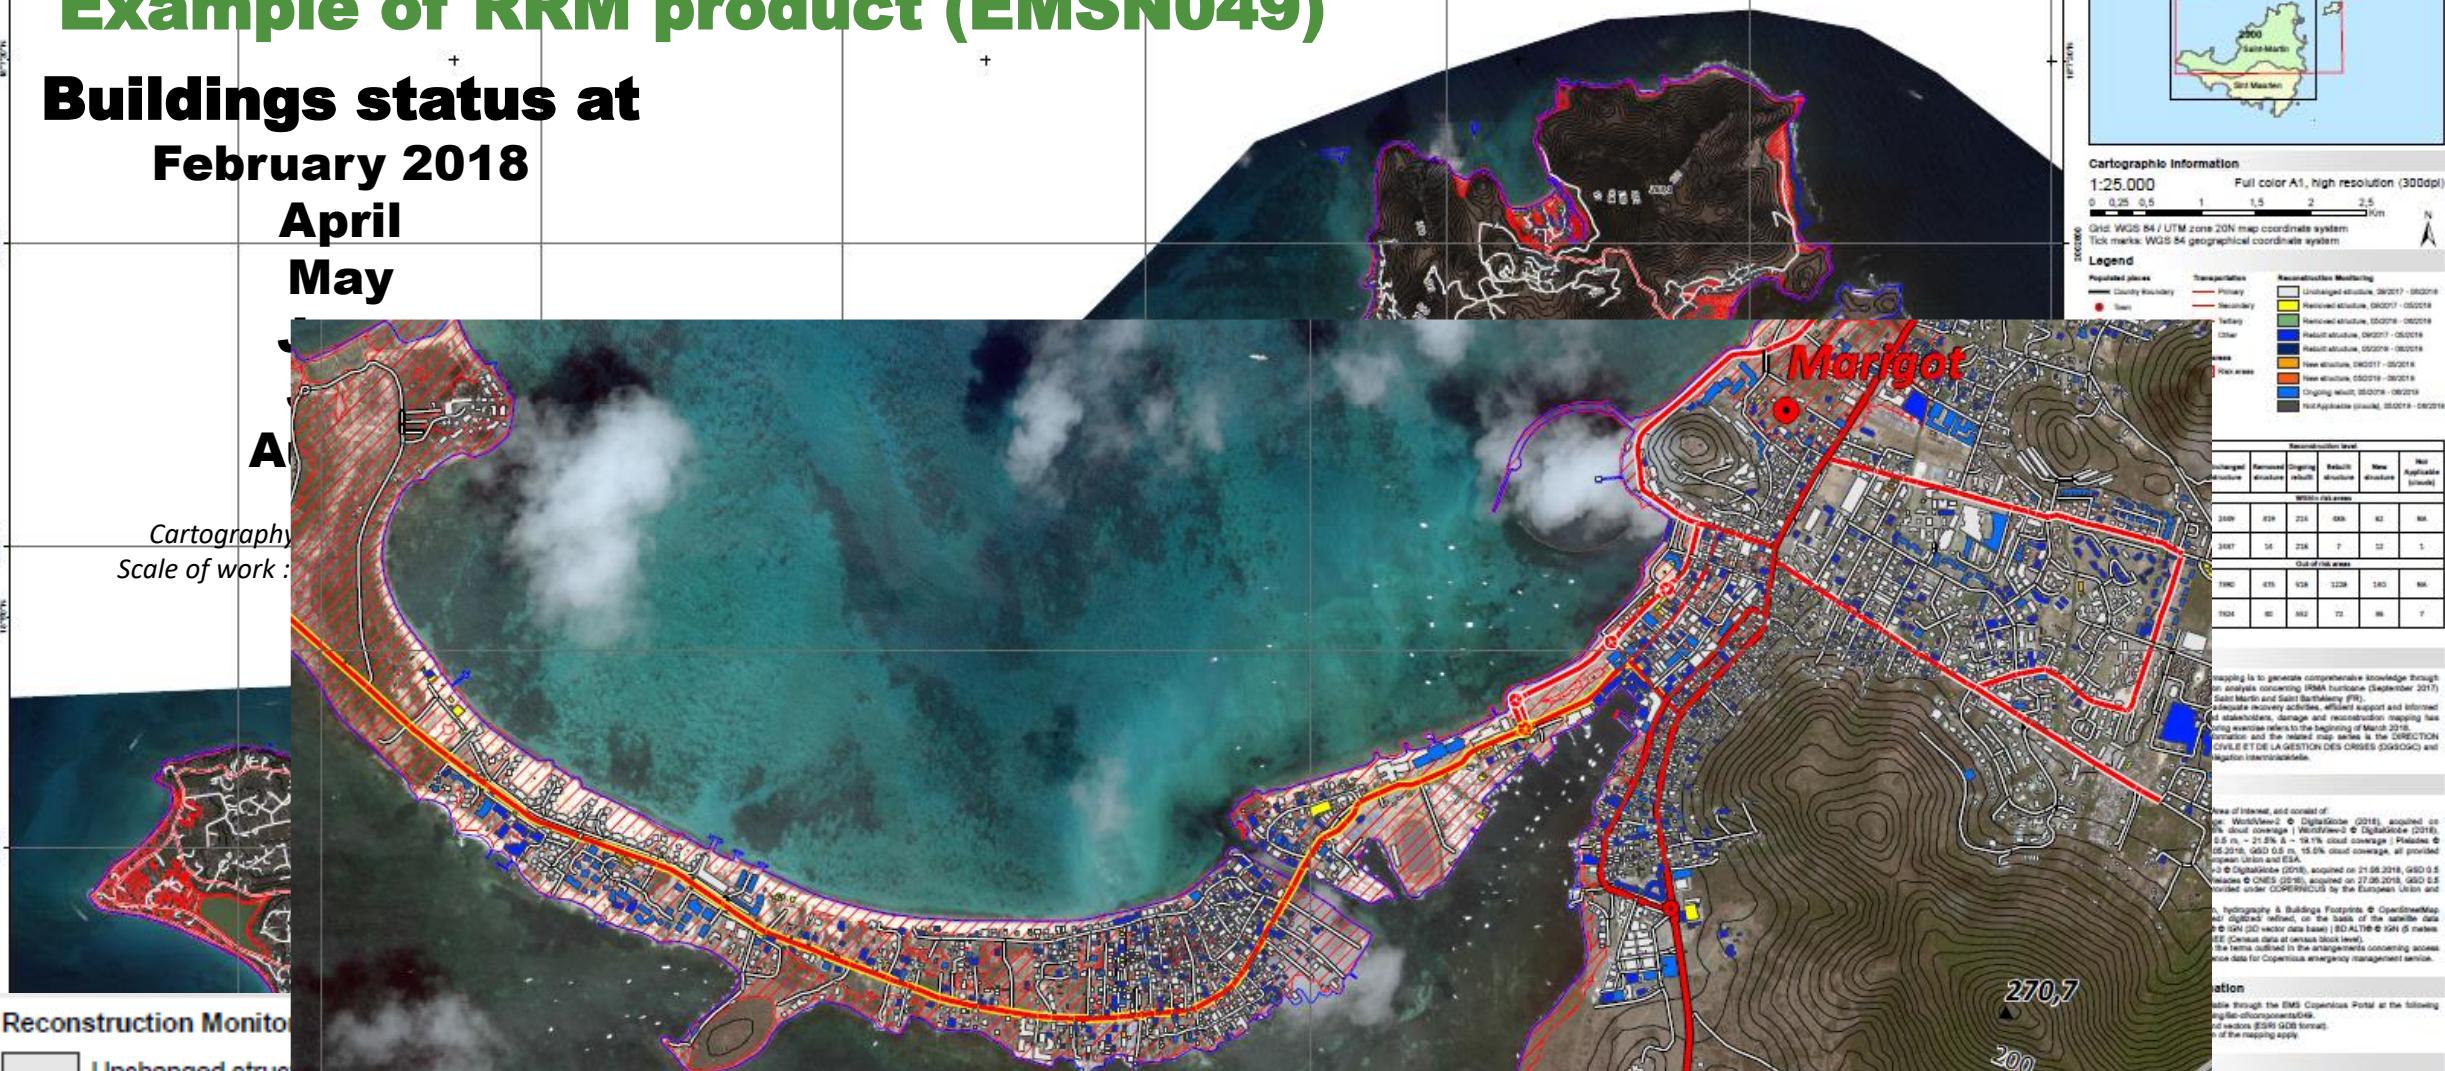
## **Buildings status at February 2018**

## Reconstruction Monitor

- Unchanged structure, 09/2017 - 06/2018
  - Removed structure, 09/2017 - 05/2018
  - Removed structure, 05/2018 - 06/2018
  - Rebuilt structure, 09/2017 - 05/2018
  - Rebuilt structure, 05/2018 - 06/2018
  - New structure, 09/2017 - 05/2018

Global accuracy 85%  
Production in ~ 1 month

The map shows the status of reconstruction of the damaged assets within two time periods.

the analysis accounted for the indication of interventions such as debris clearance, building demolition, construction activities, new structures, etc. The reconstruction category file is

using two dates optical VHR satellite data, acquired within the progress assessment time period.

The estimated geometric accuracy of the images is 2.5 m and complies with the JRC

The estimated thematic accuracy of this product is 85% or better, based on internal quality of the background satellite imagery.

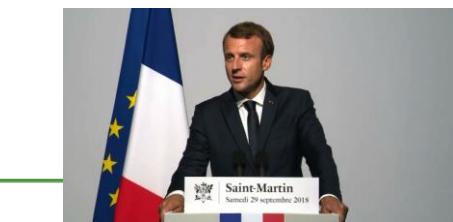
Un an après, la reconstruction a avancé, mais à des rythmes différents entre les deux îles. A Saint-Barthélemy, plus de 60 % des bâtiments très endommagés ou détruits étaient reconstruits début juillet. A Saint-Martin, où les destructions ont été plus fortes et les défis locaux sont plus prégnants, ce taux était de 35 %.
